KINKY triodes

by **J.C. Verdier**
 Laboratoire J.C. Verdier

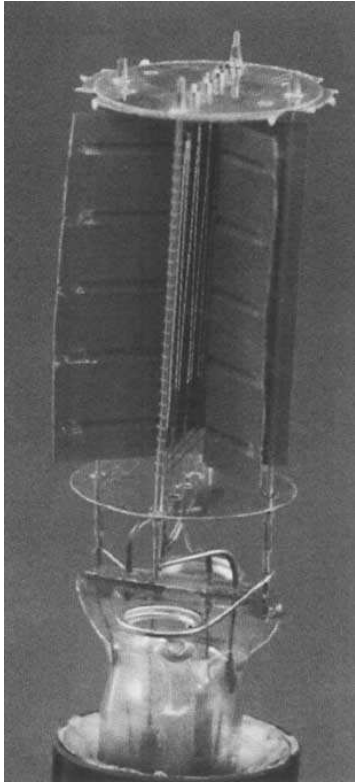
This photo shows a 300B without glass bulb whose plate has been cut with shears to examine its internal structure. We clearly see that a spire of the grid is greatly deformed and moreover the spraying of emitting coating on the filament is totally irregular and goes beyond the grid's structure down towards the base, making proper operation of the tube impossible.

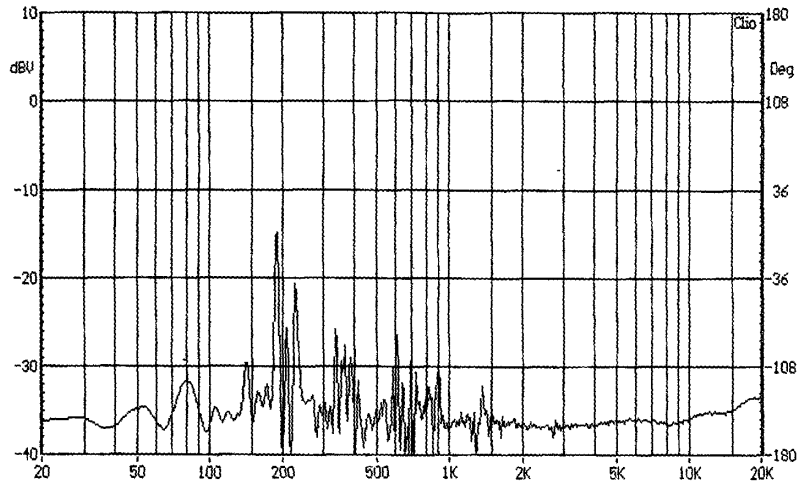
That 300B - high quality construction - but atypically the graphs show a preponderance in the resonance of the filaments and support wires located at about 200Hz while the grid's resonance is attenuated.

Examination of the graphs also shows that there are 2 main resonances. One is due to the filament movements and is generally situated about 150-200 Hz. The other has about the same magnitude but a higher frequency (about 500-700 Hz) which corresponds to the grid vibration.

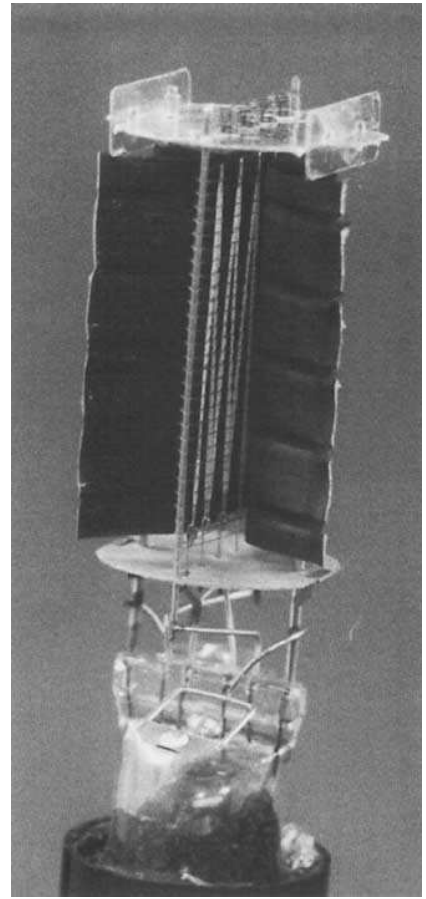
This photo shows a 300B with a regularly spaced grid and evenly applied filament coating. A little part of the emitting coating has flaked off the filament wire and is missing, but this is the only defect noticeable in this tube.

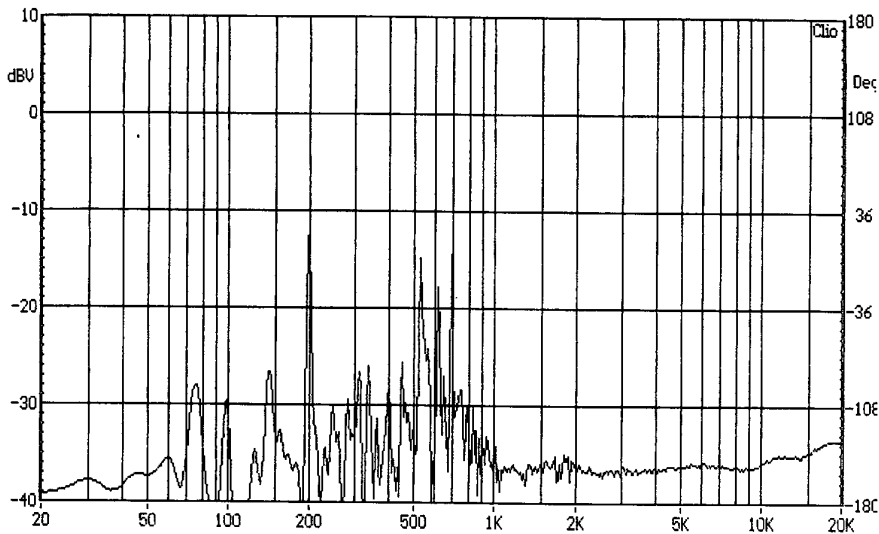
Very honorably good and typical result, it indicates precisely that we are facing a high quality production unit.

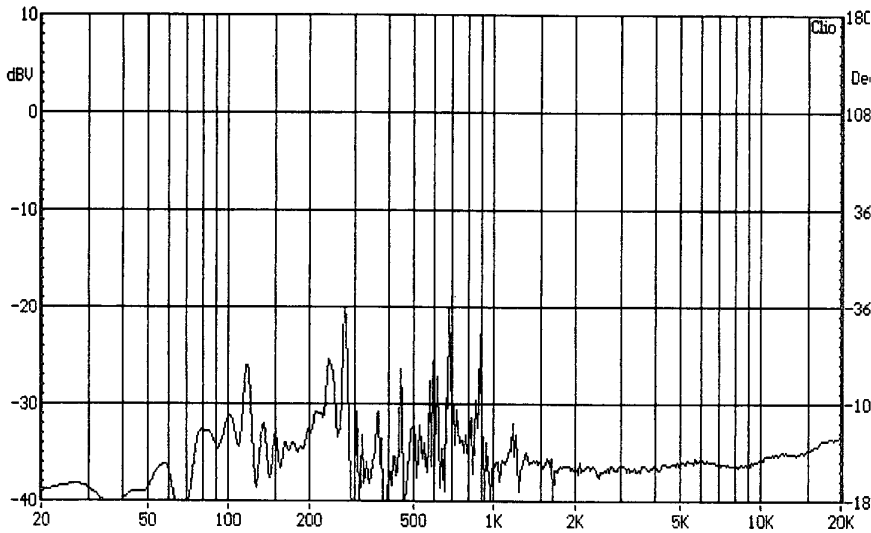
The best result obtained on those first measurements. Good blood cannot lie.

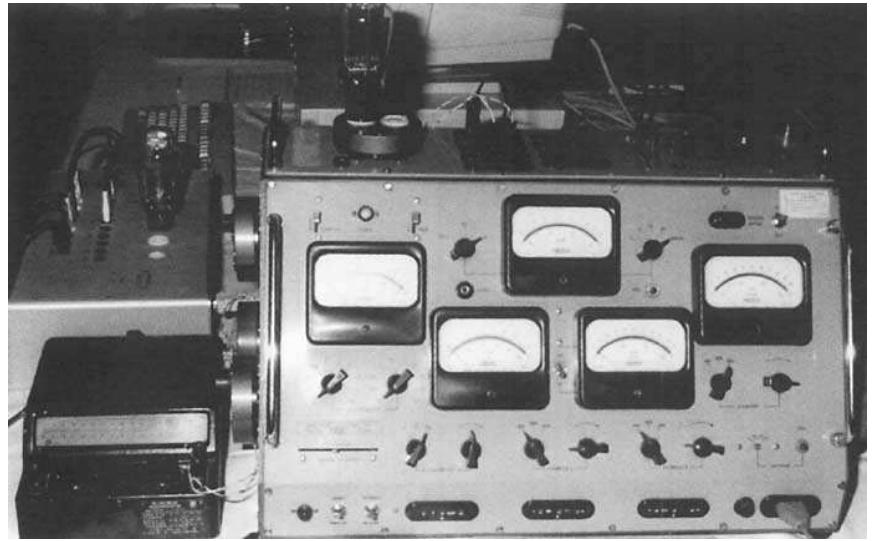
Installation prepared for the microphonics measurement. The loudspeaker is placed as near as possible to the tube. The components are locked in place so that the measurement conditions are repeatable.

The setup for the measurement I devised includes the following: a good size power amplifier (1 X 70W Monobloc in class A); a loudspeaker able to receive the power (JM LAB Profil 3); a test amplifier (2300B modified) to power the tube we have to test.

The CLIO is programmed to come out and analyze 5 consecutive salvos of MLS sound. That signal is applied to the 70W amplifier which modulates the JM LAB loudspeaker itself placed as near as possible to the 300B tube under measurement.

The amplifier carrying the 300B is prepared for the measurement, the grid of the 300B is wired to the ground to prevent signals coming from the preamplifier stage from disturbing the measurement. The output of the amplifier is connected to the input of the CLIO which makes a FFT analysis of the MLS salvos of sound and shows the average measurement on the PC screen.

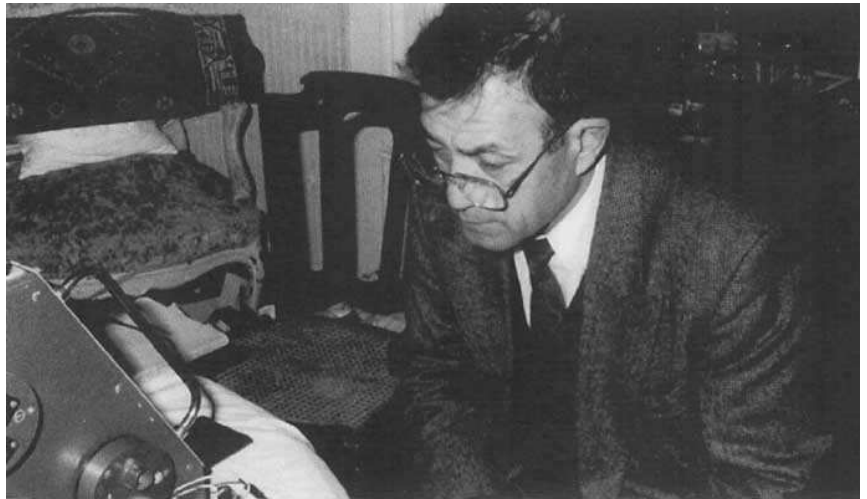
Test bench for vacuum measurement

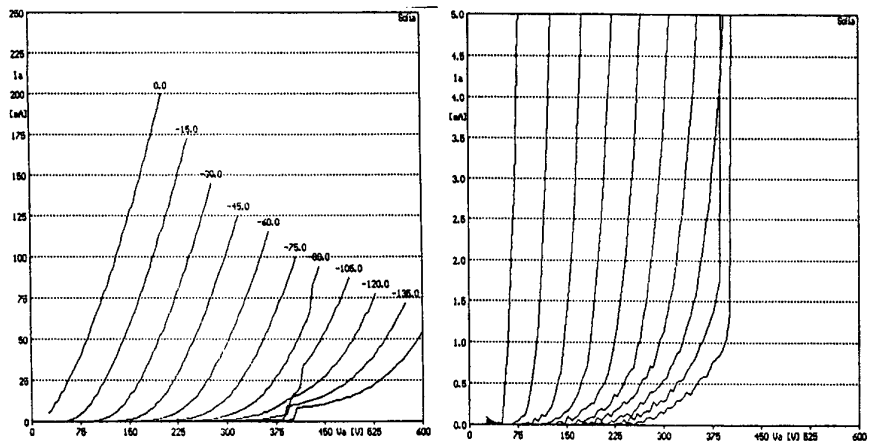
With this tube, the confusion reaches height. But we have to be honest about the cause—we dropped this tube through clumsiness and all the internal structure is twisted due to the fall. Absolutely suited only for listening to hard-rock music!

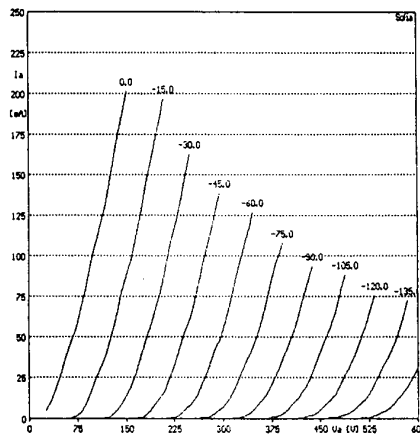
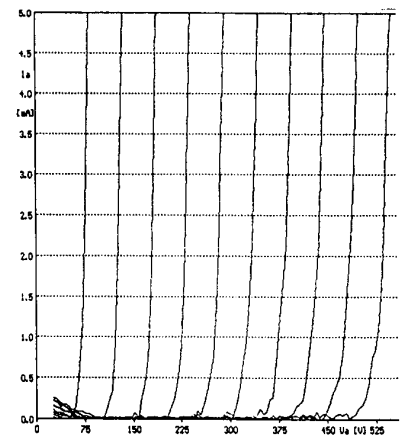
Characteristic curves of a quite perfect 300B. Left graph shows the complete curve, right graph shows the dilated curve (limited at $I_p = 5\text{mA}$). We clearly see that the plate current is completely controlled. The irregularities of this curve are due to the internal noise of the measurement system and do not reflect on tube quality.

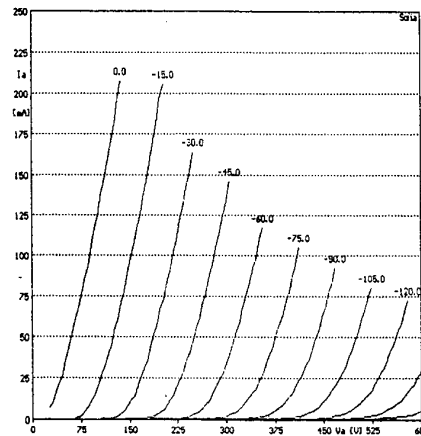
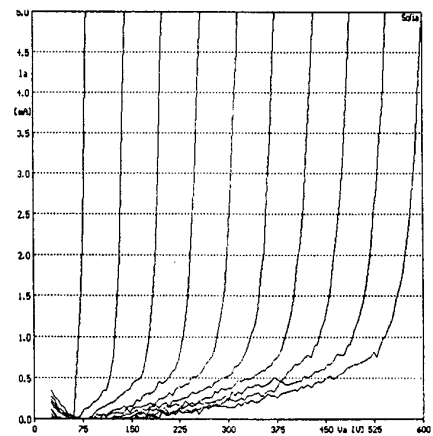
Here is a tube which is perfectly usable, but whose grid assembly has a defect. It is practically impossible to cut the anodic current while the plate voltage is $> 200\text{V}$.

Those who imagine that 300Bs having the characteristics shown on the graphs are rarities make a mistake, I meet some of them during any measurement campaign. That failure is provoked by the imperfections described in the preceding paragraph about the step of the grid and the spraying of the filament.

In fact that failure mode provokes a flatness of the signal for sine waves which wears the grid towards the very negative areas, near cut-off. That gives an important increase of "pair" harmonics (the ones which are pleasant for everybody), we have to ask a question on this matter: is that failure provoked deliberately by the manufacturer of the tubes to give a warmer sound to his product? [Nah, I think they just messed up. -ed.]

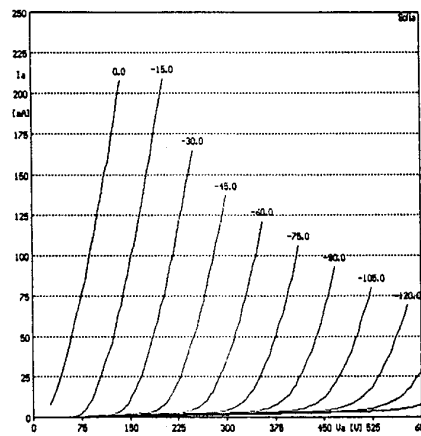
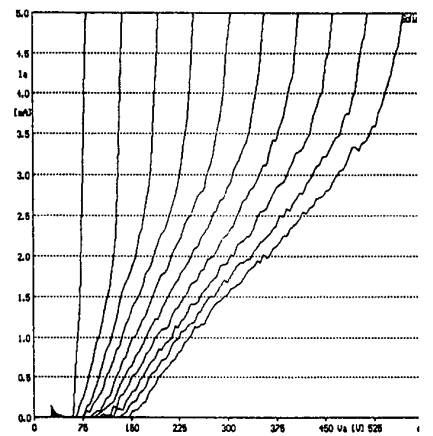
The same failure mode as above, but here it would not be possible to use the tube. This failure can be easily detected with a classic tube-tester. The current we obtain is higher than the norm and we could believe that the cathodic emission of the tube is of the best quality. Unfortunately, this is a bad interpretation. The actual cause is a serious problem in the coil geometry of the grid.
